# Manhole Inspection Summary

Manhole # S31KK1012MH

Insp Date: **2/22/07 2:20 PM**

**Location** Address: **4303 RUGBY RD**

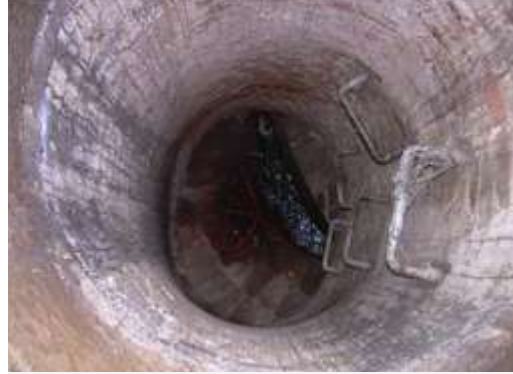
Top View

Barrel infiltration. Bench and Channel debris.

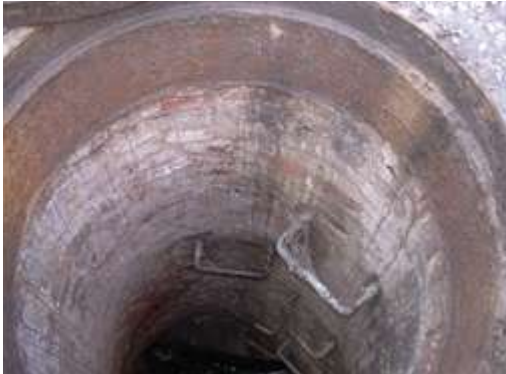
Defect

Frame leak, corbel infiltration

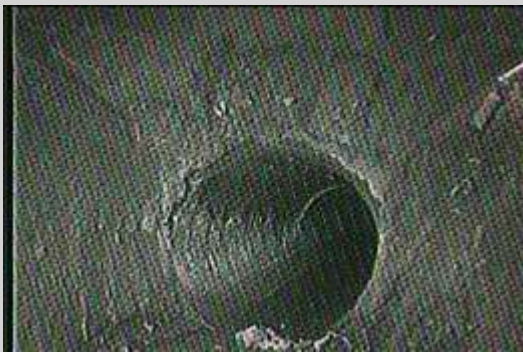
### 8 in. Circular Gravity Sewer Pipe Out @ 12 O'Clock

Infiltration: **Evidence** Pipe Seal Cond: **Unknown**

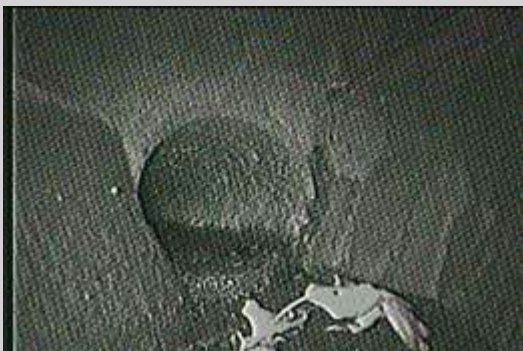
### 6 in. Circular Gravity Sewer Pipe In @ 4 O'Clock

Deposits: ☐ None ☒ **Mud** ☐ Sludge ☒ **Debris** ☐ Grease

Silt Depth: **0.5** (in.) Deposits Extent: **Light**
